Project NY 113 001-6 Technical Memorandum M-106

DEVELOPMENT OF AN IMPROVED PONTOON SYSTEM

3 August 1955

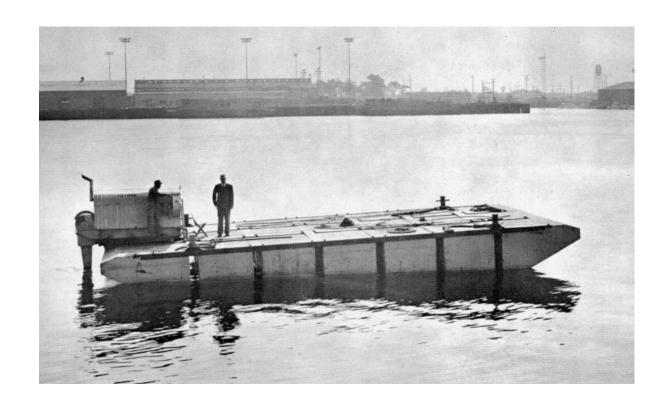
Figure 1. One  $3 \times 7$  barge of the P-1, P-2 new pontoon gear design.

The standard NL pontoons and accessory equipment were developed during the early part of 1942 and were utilized successfully in World War II. Postwar investigation was confined to improving and testing various assemblies of the pontoon gear. <sup>18</sup> The basic design of the pontoon and pontoon assemblies was not examined until June 1953, when the Laboratory initiated a study of the original design. This included consideration of fabrication, assembly, and operation of the pontoon gear and the effectiveness of various accessories. Development of an improved design followed as a result of these studies (see Figure 1).

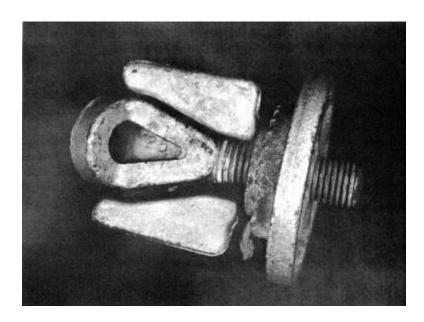
Figure 2. View of pontoon jewelry.

First consideration was given to the pontoon jewelry, Mark A3, A4, and A5 shown in Figure 2, for the following reasons: (1) an early postwar study and design<sup>6,7</sup> resulted in one-piece jewelry; however, manufacture and test proved the design to be several times more expensive than the three individual pieces; (2) tests at Davisville, Rhode Island, in 1945 and at Port Hueneme in 1946-47 indicated that the jewelry had little effect on the load-carrying capacity of a pontoon string. In these tests, the angles and corner straps of the pontoons failed before the A6 bolts. A quotation from the report states, "A6 bolts alone will withstand a shearing stress equal to, or greater than, the steel corner plates of the pontoons"; (3) a test at NAVCERELAB² indicated no serious damage to a crane barge from omission of the jewelry; and (4) discussions with field personnel revealed that the jewelry in barges

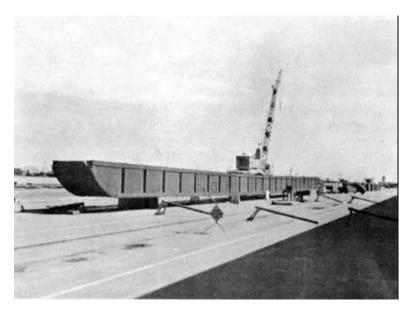
Figure 3. Static load tests viewed in process on 1 x 24 standard pontoon string with jewelry.

The investigation was started with a static load test, with and without jewelry, of a standard 1 x 24 pontoon string supported as a beam on a 100-ft span as illustrated in Figure 3. The results of these tests<sup>9,10</sup> verified the Laboratory's suspicion that the jewelry did not add to the load-carrying capacity of the pontoon assembly.

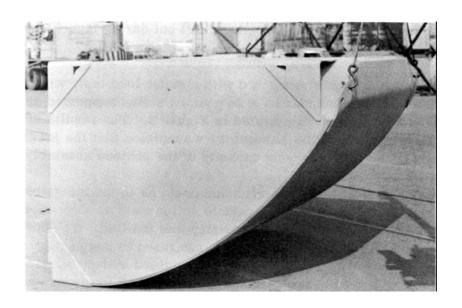
Figure 4. T7A pontoon.

The T7A pontoon shown in Figure 4 was designed with a specially curved bow plate, based on information obtained from the Dravo Corporation, Pittsburgh, Pennsylvania, relative to the most efficient shape of hull designs. The 3/8-in bow plate was used because the bow and stern of the barge receive the most abuse. The curved shape, however, made fabrication difficult and costly.

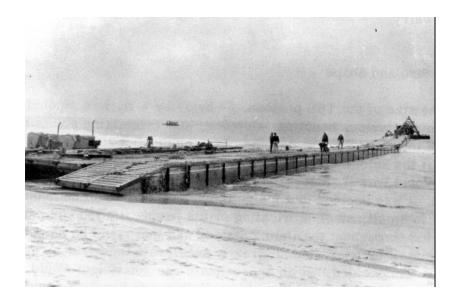
Figure 5. T8 and T11 pontoons forming slope from T6B pontoon to beach.

An investigation of the T8 and T11 pontoon designs shown in Figure 5 revealed that a ramp from the deck of a barge or causeway to the beach was found necessary in the early part of World War II. Initially, a T7A was inverted, and a long wooden ramp was used from part way down the pontoon slope to the beach (see Figure 6).

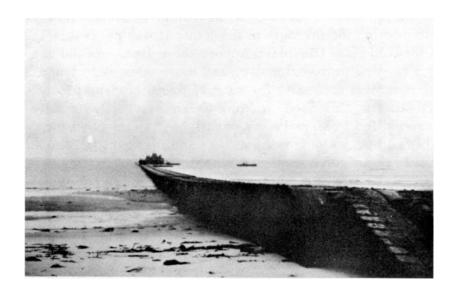
Figure 6. Inverted T7A pontoon with wood ramp.

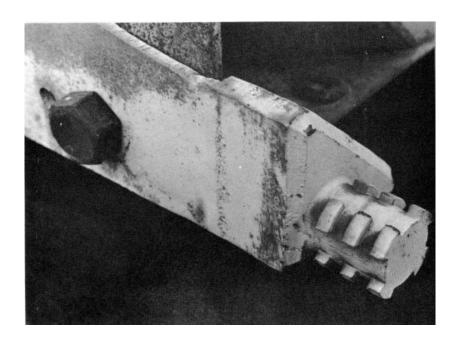
Figure 7. Male section of angle breech plug splice.

One part of the angle design which was studied closely was the breech plug splice (see Figures 7 and 8). This splice was originally intended to join angles together without field-welding. However, in order to develop the strength of the joint, it was necessary to field-weld a tapered plate (fishplate) across the splice. As the use of the pontoons became more extensive, and more uses were found, field-welding became a necessity for ramps, propulsion-unit foundations, etc. Paralleling this need, welding became more universally used and more skilled welders became available, so the need for field-assembly without welding became less and less a requirement, until today it is no longer considered a requirement.

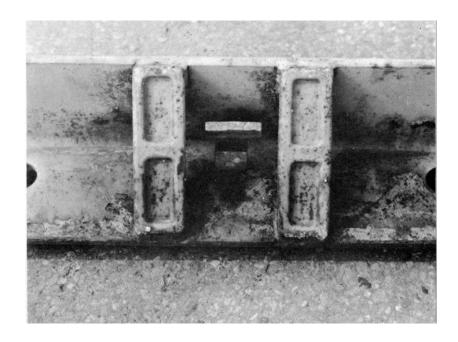
Figure 9. Rectangular link and pin holes located between the wedge bars on standard pontoon angle.

Structurally, the rectangular link and pin holes in the angles between pontoons severely penalized the angles at the critical sections (see Figure 9). An engineering appraisal of the link and pin (Figure 10) showed that they were of little structural value, the link having only 1.0 sq in. of metal in shear and tension, and the pin only 1.5 sq in. of metal in shear. Further, it was determined by test that they were not necessary for the assembly of strings of pontoons, if P-5 plates and the assembly clamp shown on Y&D Drawing 146,272 were utilized.

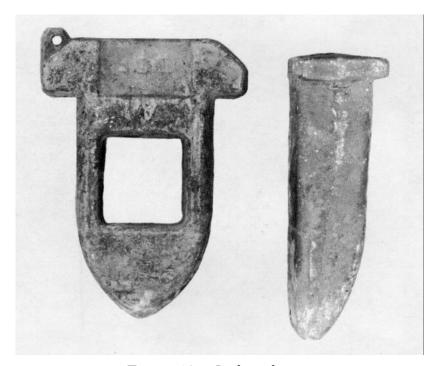
Figure 10. Link and pin.

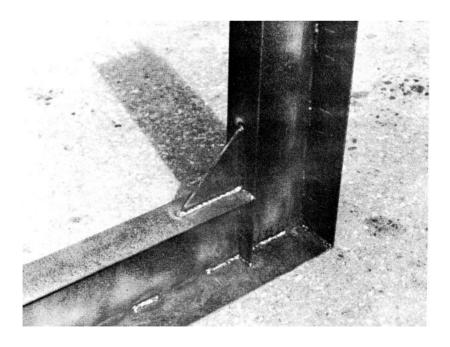
Figure 11. View of interior framing of T6B pontoon.

The discussions with six fabricators gave an insight into the problems encountered in the manufacture of pontoons. The consensus of opinion was that the cut-off corners of the pontoons, fitting of interior framing, positioning and welding of the corner straps, and the large amount of inside welding were the trouble spots in fabrication. The cut-off corners necessitated accurate shearing of the four corners of all plates as well as all four edges, and the closure plates were difficult to form and to fit into the triangular opening. The interior framing had to be cut accurately to length, and the Junior Beam had to be split exactly in half in order to obtain a proper fit at the edges of the pontoon (see Figure 11).

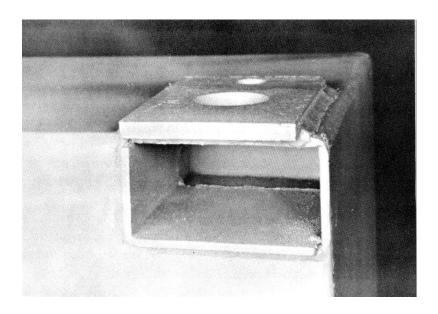
Figure 12. Preliminary design of corner box of P-1 pontoon.

After considerable study, it was decided that a small watertight, open-end box in each corner, into which a loose, flanged nut could be placed at time of assembly, would be the most advantageous solution to the problem (see Figure 12). The flanged nut shown in Figure 13 was designed to be forged from SAE 1040 steel. The position of the nut on the present pontoon is governed by the position of the jewelry. With elimination of the jewelry, the position of the nut in the new pontoon could be moved closer to the corner of the pontoon, making the nut more accessible in the corner box and reducing the distance between bolt holes in adjacent pontoons, thereby reducing bending in the assembly angles. Elimination of the corner strap previously made it possible to make the downstanding leg of the assembly angle flush against the pontoon, thereby affording protection to this leg of the angle.

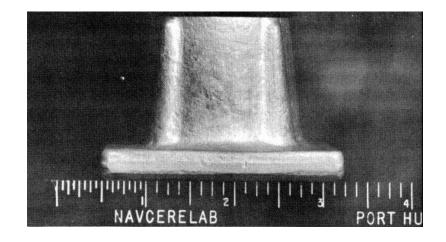
Figure 13. Preliminary design of loose flanged nut.

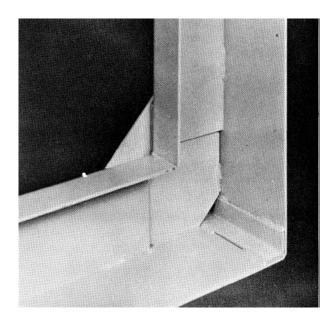
Figure 14. Preliminary design of interior angle framing of P-1 pontoon formed from 3/16-in. plate.

Considerable study of the framing was made in order to have members which were not proprietary items and which could be easily joined at the corner of the pontoon. First, a review was made of all commercially rolled shapes in an attempt to find a standard shape that had the same section modulus and weight as the Junior Beam. It was found that all of these standard shapes were heavier than the Junior Beam. Next, structural shapes formed from plate were investigated. For uniformity of material, 3/16-in. thick plate, the same as the pontoon shell, was chosen for investigation. Calculations showed that a 5-1/2 by 3- by 3/16-in. formed angle had very nearly the same section modulus and weight as the Junior Beam. This angle section also made possible elimination of the difficult fitting problem in the pontoon corner. interior framing members were all made the same length (4 ft 0 in.), leaving a clearance at each end, structural continuity around the corner being accomplished with a gusset made of 3/16-in. plate (see Figures 14 and 15). Launching tests on the P1X pontoon revealed that by flanging these gusset plates, considerable additional strength could be obtained (see Figures 16 and 17).

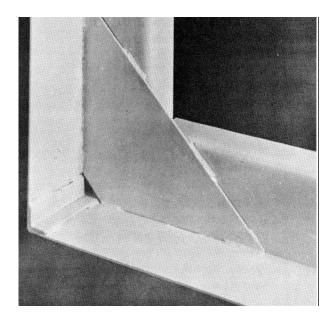
Figure 15. Preliminary design of angle framing of P-1 pontoon, showing 3/16-in. plate gusset at corner.

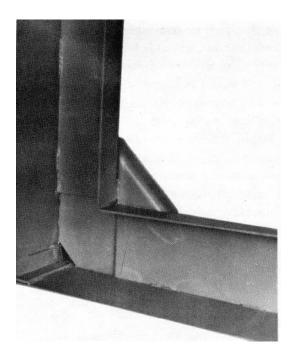
Figure 16. Final design of interior framing, showing flanged gusset formed from 3/16-in. plate.

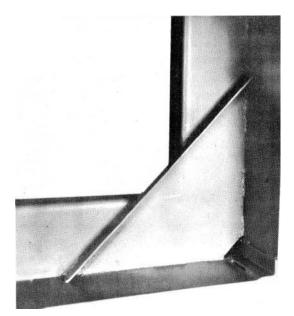
Figure 17. Final design of interior framing showing flanged gusset.

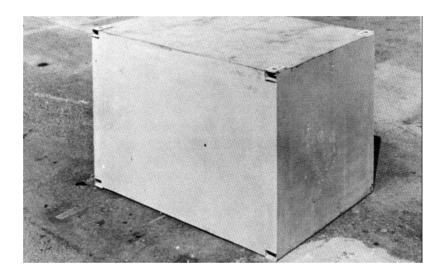
Figure 19. View of P-1 pontoon assembled.

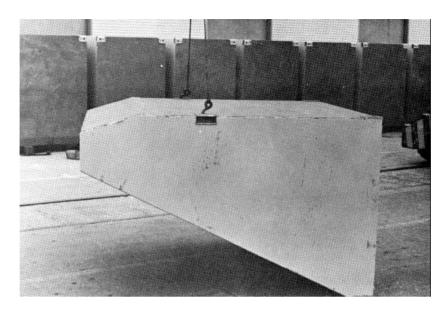
Figure 21. P-2 pontoon viewed in position to be used as a bow or stern.

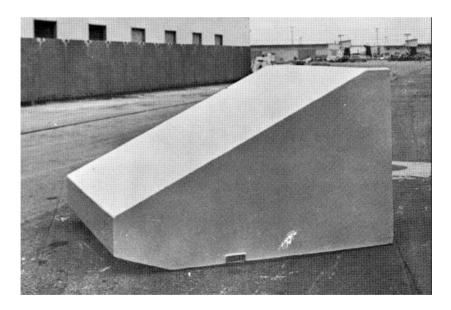
Figure 22. P-2 pontoon in position to be used as a ramp pontoon.

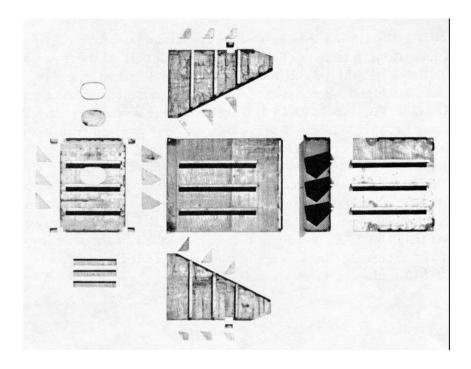
Figure 23. View of P-2 pontoon parts in display.

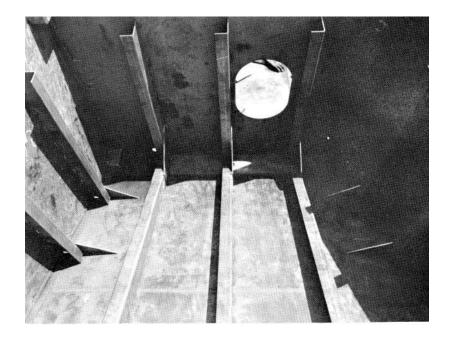
Figure 24. Interior framing of P-2 pontoon, showing angles and gussets.

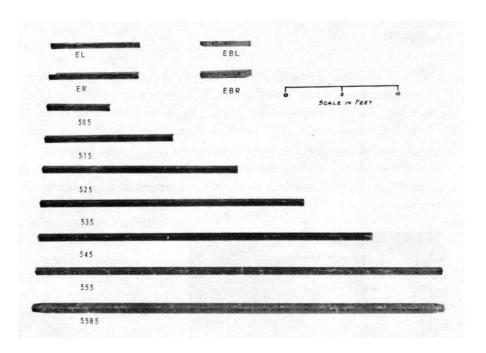
Figure 25. View of new design pontoon angle series in display.

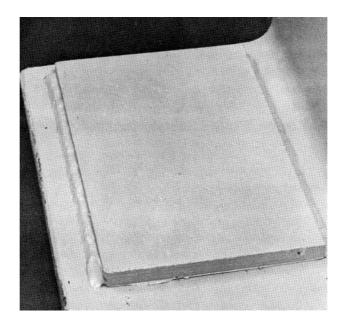
Figure 26. Steel plate, 3/8 in. thick, welded to inside leg of new pontoon angle.

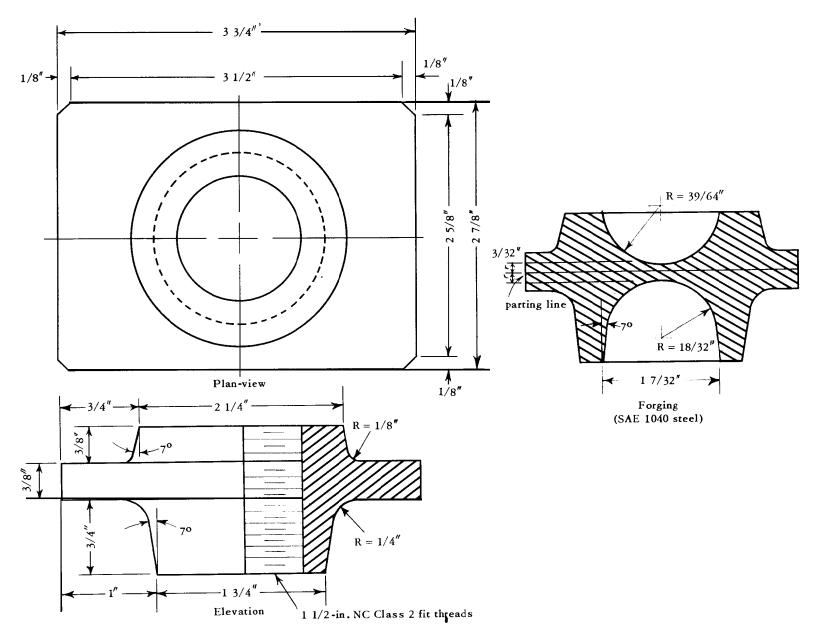
Figure 28. Drawing of redesigned loose flanged nut.

with the flange on the nut. This meant that the weld on the inside of the pontoon had to be watertight the first time or the pontoon would have to be opened up after test to repair any leaks. To eliminate this problem, the nut design was changed (see Figures 27 and 28), and the flange was moved down far enough to permit welding on the inside of the nut box.

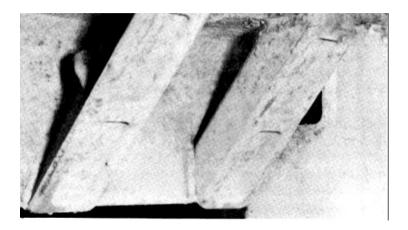
Figure 29. View of standard angle and P1X pontoon corner.

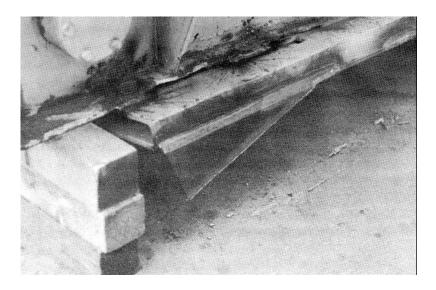
Figure 30. Standard unit foundation with tapered plate to fit P-2 pontoon.

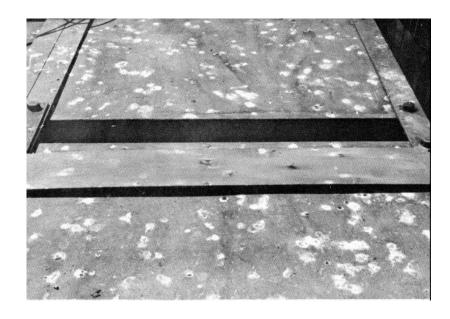
Figure 31. New pontoon deck closure placed beside opening.

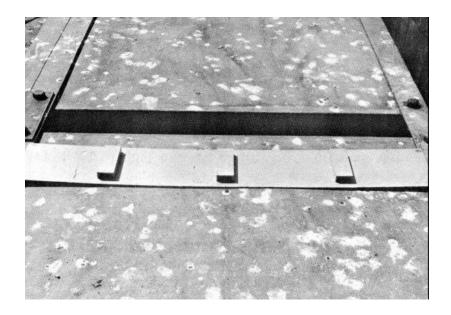
Figure 32. New pontoon deck closure showing back side with channel stiffeners.

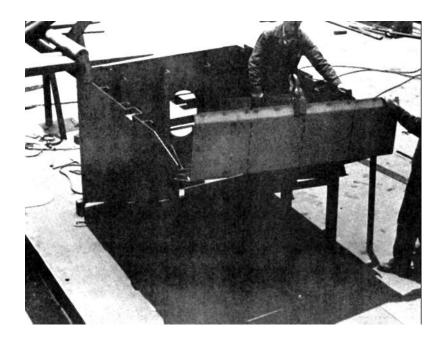
Figure 33. View of assembly of P-2 pontoon.

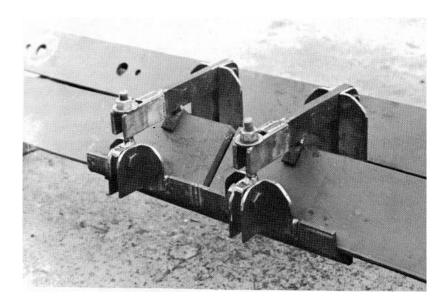
Figure 34. Clamp used to position new angles while welding.

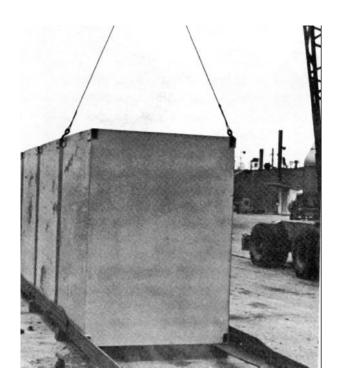
Figure 35. Assembling P-1 pontoons in new angles.

Since one of the main factors of the new design was the ease of assembly, this feature was carefully observed during the assembly of a 1 x 24 string, a 3 x 7 barge, and a 3 x 12 ramp landing barge. In all cases, the angles were laid out and welded together easily (see Figure 34), and the hole spacing across the welded splices was easily maintained. The pontoons were easily placed in the angles, using cable slings with hooks that fitted into the bolt holes in the corners of the pontoons (see Figure 35). The 3/8-in. plate on the

angle helped considerably in placing the pontoon so that the 1-5/8 in. hole in the angle and the 1-5/8 in. hole in the corner of the pontoon were in alignment. The loose, flanged nut was easily placed, and the 1-1/2 in. dia. A6 bolt could be started by hand, with the final tightening being accomplished by an air wrench. The pontoon strings were attached to each other with the AP-1 plates, top and bottom, with no difficulty being encountered due to the loose nut.

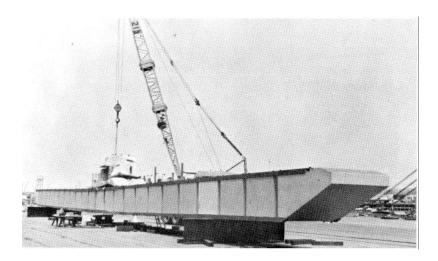
Figure 36. Static load tests of new pontoons and angles.

The early Laboratory tests for effectiveness of the pontoon  $j \, e \, w \, e \, l \, r \, y^{9,10}$  were made on a 1 x 24 pontoon string supported on a 100-ft span. Consequently, for comparison of the new design with the present design, a similar test was made on a 1 x 24 string of new pontoons and angles (see Figure 36). The recorded stresses and deflections are shown in Figures 37 and 38.

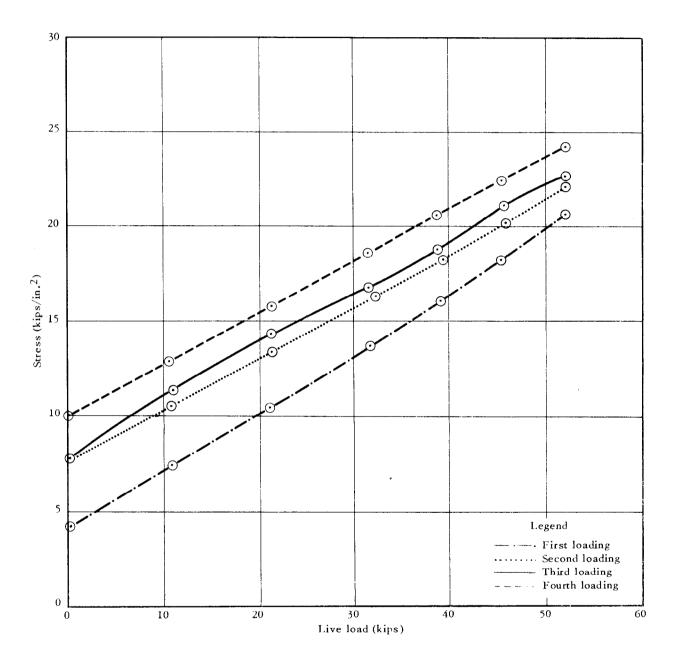
Figure 37. Tension stresses on 8-in. angle at center of 1  $\times$  24 string of new pontoon design on 100-ft span.

The 1 x 24 string of the new design was made of a combination of 6- and 8-in. angles, while the string of the present design was assembled with all 8-in. angles. The stresses in the angles of the new design were approximately 30% less and the deflection was approximately 20% less than those of the present design. The decreases in stresses and deflection were attributed to elimination of the link and pin holes and placing of the A6 bolts closer together in adjacent pontoons.

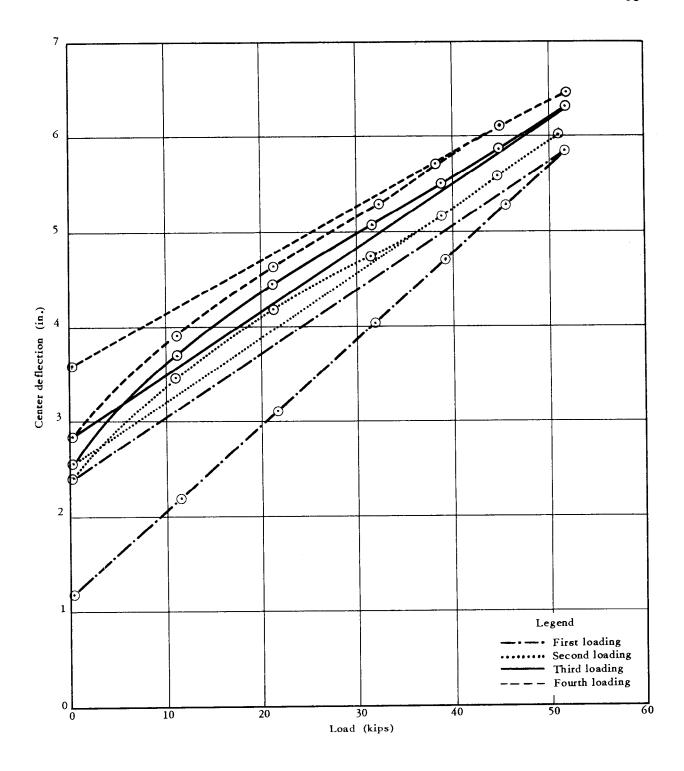
Figure 38. Center deflection vs load, 1 x 24 string of new pontoon design on 100-ft span.

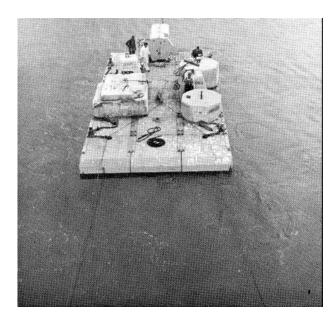
Figure 39. One 3 x 7 barge, new pontoons, during bollard tests. Barge in reverse position.

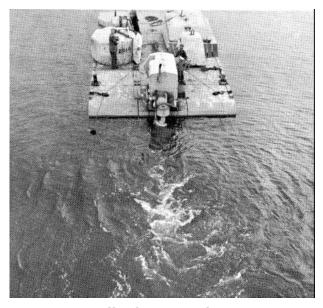
Figure 40. Bollard tests with new pontoons. Barge in forward position.

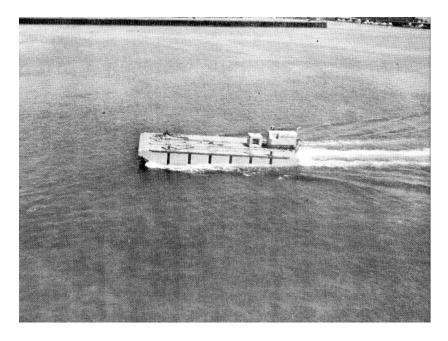
Figure 41. One 3 x 7 barge, assembled with new design pontoons and angles, during test.

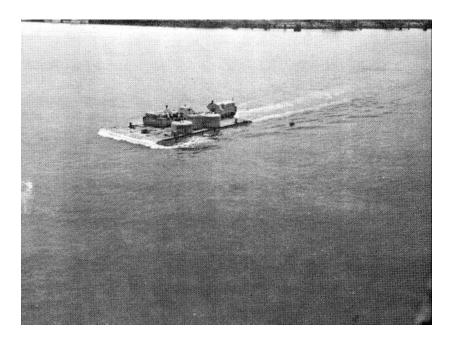
Figure 42. One  $3 \times 7$  barge, new pontoons and angles, with 50-ton load during tests.

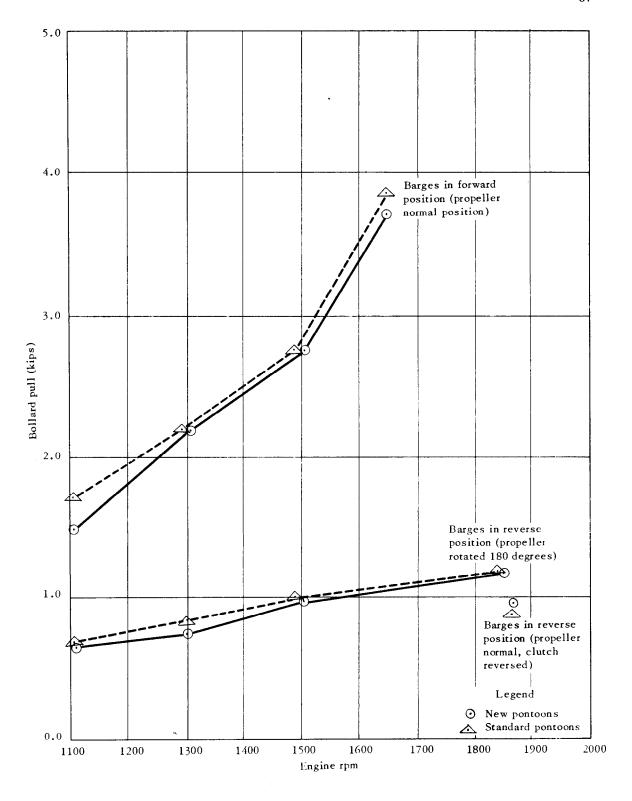
Figure 43. Bollard pull vs rpm with no load on barge.

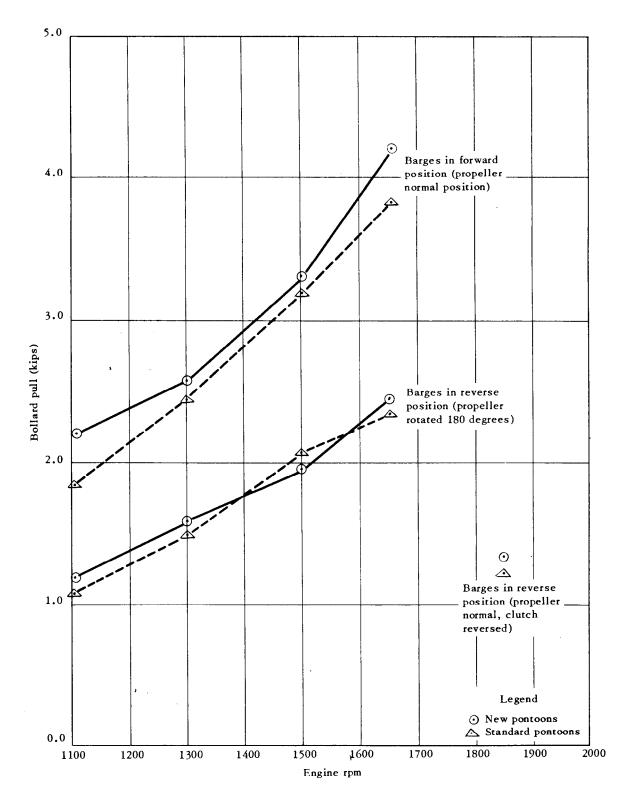
Figure 44. Bollard pull vs rpm with 30-ton load on barge.

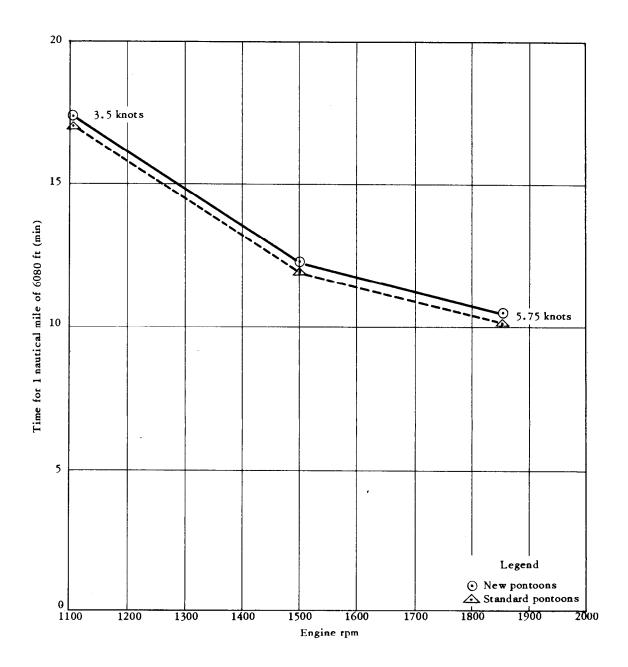
Figure 45. Speed vs rpm with no load on barge.

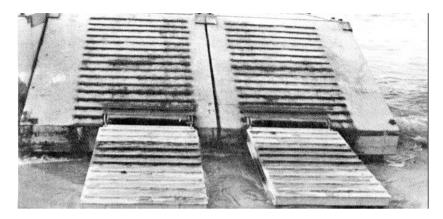
Figure 46. Hinged ramp for P-2 pontoon.

In order to evaluate the P-2 pontoon for use as a ramp and the  $3 \times 12$  barge for LST side-launchings, a  $3 \times 12$  ramp barge was assembled. A new type of hinged ramp (see Figure 46), fabricated from steel WF beams and plate, was used from the front end of the P-2 pontoon to the beach. This ramp weighed 400 lb or approximately two-thirds of the weight of the present type of wooden ramp.

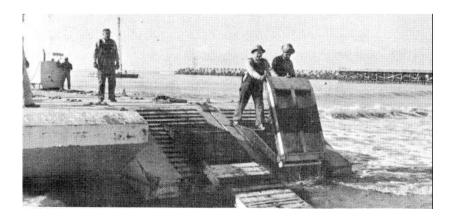
Figure 47. Hinged ramp with adapter slope for P-2 pontoon.

In the test as a ramp, it was found that the slope of the P-2 could be satisfactorily negotiated by all available vehicles except the extra-long-wheel-base vehicles such as the flat-bed truck, 4-ton 6 x 6, 4 DT, 172-in.-wheel-base, cab-protected and winch-rear-mounted, which is now obsolete. The hand-brake band on the drive shaft just touched the top edge of the angles as the truck went up the ramp. It was decided that an adapter slope (see Figure 47) could be put on the P-2 pontoon to make the slope entirely satisfactory for all types of vehicles (see Figures 48 and 49). This slope attachment is much less expensive than an extra or longer pontoon. Attachment is to be made by welding in position at the same time that the hinge and the cleats are welded on the ramp P-2 pontoons.

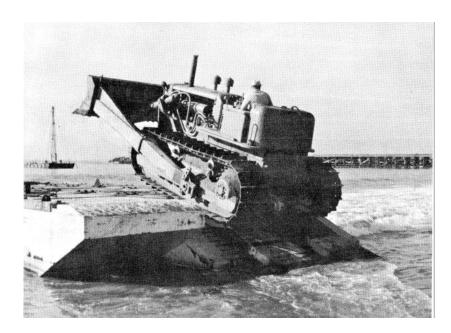
Figure 48. HD19 tractor boarding new design landing barge.

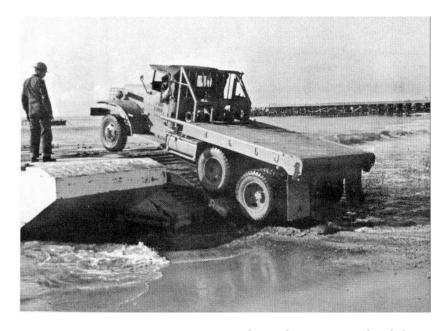
Figure 49. Four-ton,  $6 \times 6$  truck with 172-in. wheel base loading on the new ramp and ramp adapter.

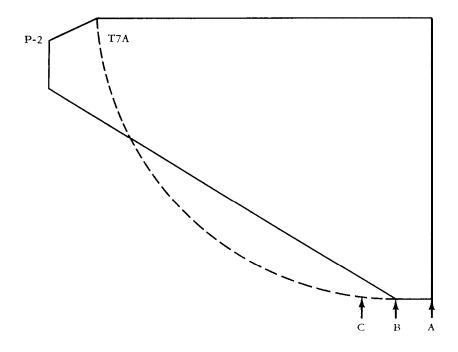
Figure 50. Sketch showing comparison of watercontact areas of present and new design pontoons.

First Launching. The barge was launched from the height of the Class 1156 LST, 6-ft 6-in., with and 02D unit mounted on the center of the outboard string. No special reinforcement was used to stiffen the structure. Upon impact with the water, the P-2 pontoon holding the propulsion unit broke loose from the top angles and resulted in failure of the bottom angles. Inspection showed that the A6 bolts holding the P-2 pontoon to the top angles failed and transferred the full bending load to the two bottom angles. Further inspection indicated that the failure of the A6 bolts was due to the extra length of the P-2, its straight-sloping bottom, and the lack of reinforcement necessary when launching from the 6-ft 6-in. height. The T7A pontoon (7-ft 0-in. ) has a curved bottom, which provides additional support to the angles upon contact with the water (see Figure 50).

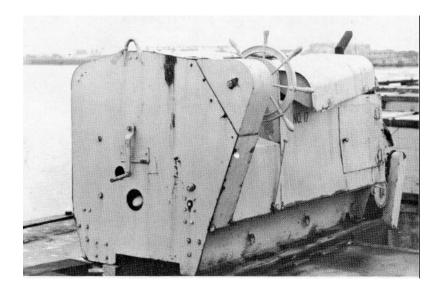
Figure 51. View of extended propulsion unit foundation.

Second Launching. For the second side-launching test, the 02D unit was moved to a position over the outboard double angles and the propulsion-unit base frame was extended in length to weld to the adjacent P-1 pontoon (see Figure 51). No additional reinforcement was used. The barge was launched from a height of 4 ft 7 in. Resulting damage consisted of a slight bending of the outboard pontoon angle.

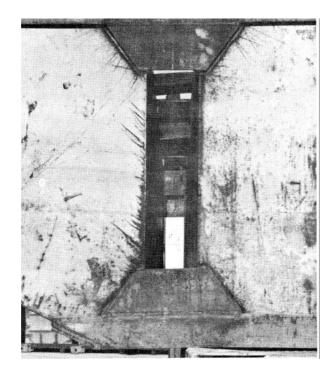
Figure 53. View of reinforcing shear plates.

Third Launching. The third test was made from a height of 5 ft 8 in. with an 02D unit mounted over the outboard double angle (see Figure 52). Reinforcing shear plates were added to the angles at the opening between the stern P-2 and P-1 pontoons (see Figure 53).

These plates, installed during assembly of the angles, are 18 by 1/2 by 9 in. An accelerometer was mounted directly in front of the propulsion unit to measure the impact of the barge upon entering the water. No apparent damage to the barge was found after launching except the indentation of the pontoon bottom plates similar to that on the standard T6B. Maximum deceleration was measured at approximately -35 g.

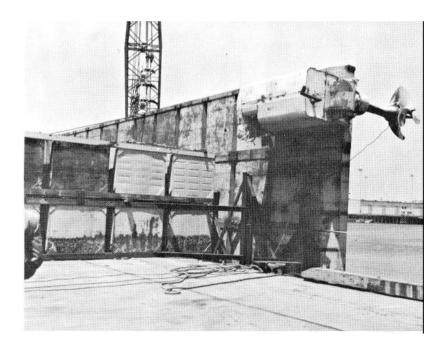
Figure 54. Barge ready for fifth launching.

Fifth Launching. The 02D unit was moved to the center of the outboard string (see Figure 54) and the barge was launched from a height of 4 ft 7 in.

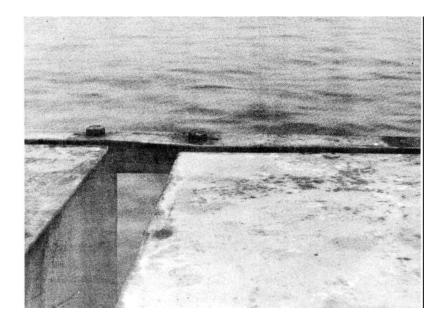
Figure 55. Close-up of slight bending of outboard and angle due to launching with propulsion unit on outboard string of barge.

The barge reinforcement was the same as in the third and fourth launchings: that is, the propulsion-unit base frame was extended to the adjacent P-1 pontoon, and one row of 18- by 1/2- by 9-in. shear plates was welded to the angles and pontoons. The deceleration of the barge was measured at -23 g. The outboard pontoon angle bent slightly (see Figure 55) at the second pontoon spacing from the stern of the barge, and the bottom plate of the P-1 pontoon in front of the propulsion unit failed at the bottom seam due to progressive indentation. However, the barge was still operable.

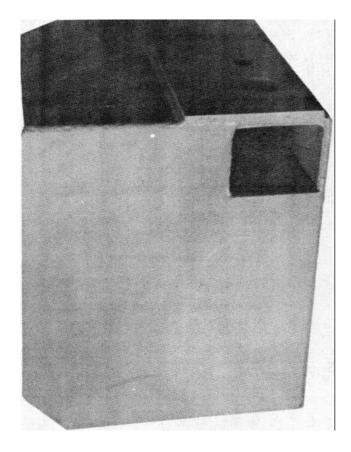
Figure 56. Final design of new nut receptacle, exterior view.

Seventh Launching. The barge without further modification was launched again from a 4-ft 7-in. height. Damage resulting from this launching included weld failures at four of the corners of the pontoons where the top plate joins the side plate, shear failure of two A6 bolts, and further indentation of the pontoon bottom plates. The barge was still operable. Inspection of the weld failures showed an insufficient amount of weld area in the seam to resist the repeated launching impacts. The nut receptacle was redesigned to strengthen it and also to simplify its fabrication (see Figures 56 and 57).

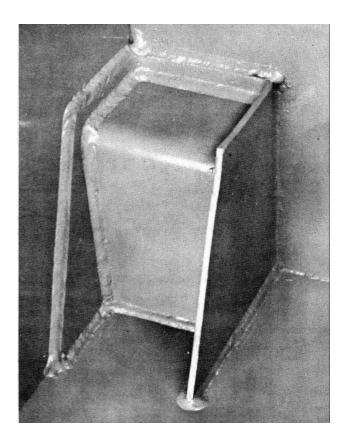
Figure 57. Final design of new nut receptacle, interior view.
